DEPARTMENT OF TRANSPORTATION

Quality Assurance and Source Inspection

Contract #: 04-0120F4Cty: SF/ALA Rte: 80 PM: 13.2/13.9File #: 69.28**WELDING INSPECTION REPORT****Resident Engineer:**Siegenthaler, Peter**Address:** 333 Burma Road**City:** Oakland, CA 94607**Report No:** WIR-025301**Date Inspected:** 14-Jul-2011**Project Name:** SAS Superstructure**OSM Arrival Time:** 700**Prime Contractor:** American Bridge/Fluor Enterprises, a JV**OSM Departure Time:** 1900**Contractor:** Zhenhua Port Machinery Corporation, Ltd (ZPMC), Changxing Island **Location:** Shanghai, China**CWI Name:** Mr. Mai Quin Li**CWI Present:** Yes No**Inspected CWI report:** Yes No N/A**Rod Oven in Use:** Yes No N/A**Electrode to specification:** Yes No N/A**Weld Procedures Followed:** Yes No N/A**Qualified Welders:** Yes No N/A**Verified Joint Fit-up:** Yes No N/A**Approved Drawings:** Yes No N/A**Approved WPS:** Yes No N/A**Delayed / Cancelled:** Yes No N/A**Bridge No:** 34-0006**Component:** Bike Path Components**Summary of Items Observed:**

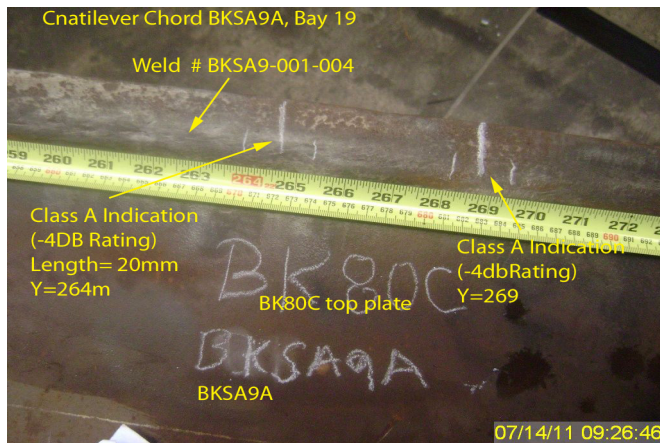
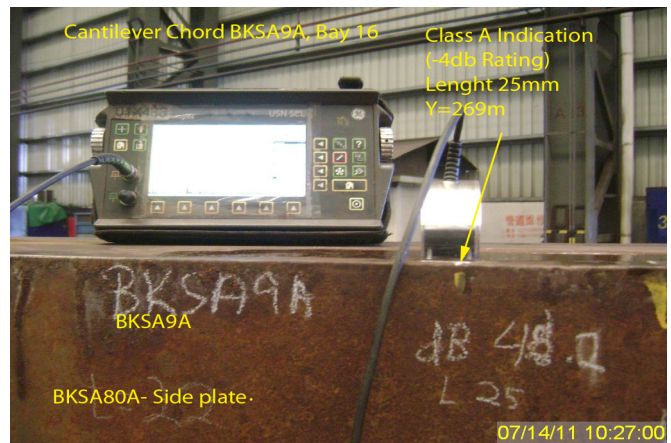
Description of Incident: During the Quality Assurance (QA) NDT inspection of an OBG Bike Cantilever Truss BKSA9A, is in Bay 16, this QA Inspector discovered the following issues. This weld was retested on this date to verify indications and to generate a Incident Report :

- 1st Class "A" indication measuring 20mm in length.
- The Indication rating is -3.9db.
- The depth of the indication is approximately 21.76mm.
- The weld joint is identified as BKSA9-001-001.
- The weld joint is a Complete Joint Penetration (CJP) groove weld joining BKX80C-Top Plate to BKX80A-Side Plate, BKSA9-001-001~004.

- The thickness of the BKX80A-Top Plate is 22mm.
 - The X location is +10.
 - The Y location is approximately 269mm.
 - The indication is clearly marked on or near the weld.
 - BKSA9A is currently located in Bay 16.
-
- 2nd Class "A" indication measuring 25mm in length.
 - The Indication rating is -4db.
 - The depth of the indication is approximately 21.76mm.
 - The weld joint is identified as BKSA9-001-001.
 - The weld joint is a Complete Joint Penetration (CJP) groove weld joining BKX80C-Top Plate to BKX80A-Side Plate, weld #BKSA9-001-001~004.
 - The thickness of the BKX80A-Top Plate is 22mm.
 - The X location is +10.
 - The Y location is approximately 269mm.
 - The indication is clearly marked on or near the weld.
